Equipment Wash Rack Upgrade

Prairie Dunes Country Club, Hutchinson, Kansas

BY JOSHUA CONWAY, AUDUBON INTERNATIONAL

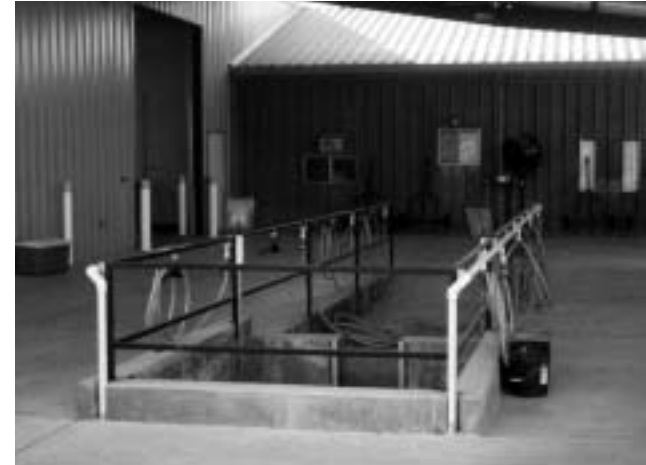
The redesigned and greatly improved wash pad at Prairie Dunes Country Club provides adequate collection and filtering of wash water.

that drain to a collection/filtering system. Instead, the club moved the collection system into the center of the courtyard and doubled the number of wash stations. Each of the eight stations has a separate hose supplied from the irrigation system; a back-pack blower, pale, and shovel for clipping removal; and a "safety stick" (mandatory for adjusting reel parts during cleaning rather than using hands).

The design of the system is quite simple. The concrete pad is slightly sloped to enhance movement of rinse water and clippings into the collection pit from both sides. Rinse water is double screened to collect clippings before passing through a buried oil/water separator tank, much like a septic tank. The filtered water is discharged into a leach field.

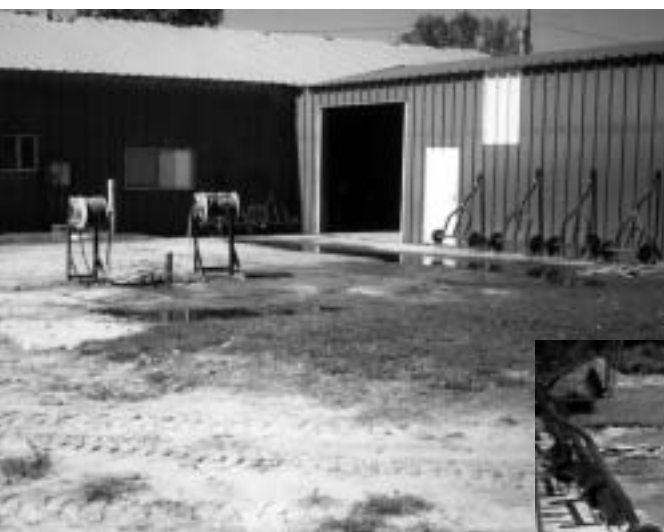
Superintendent Stan George had long felt the club needed a new wash rack system. The old wash pad consisted of two hoses on a 400 square foot, irregular concrete base. Constructed from concrete leftover from past projects, the uneven surface caused the accumulation of rinse water on the pad itself. In addition, the drains were failing, allowing unfiltered rinse water to stagnate above ground and potentially degrade ground water.

Failing drains and stagnate water were plaguing Prairie Dunes Country Club's wash pad before the upgrade.
